Triggered Surface Slips in Southern California Associated with the 2010 El Mayor-Cucapah, Baja California, Mexico, Earthquake

Open-File Report 2010-1333

Jointly published as California Geological Survey Special Report 221

By Michael J. Rymer, Jerome A. Treiman, Katherine J. Kendrick, James J. Lienkaemper, Ray J. Weldon, Roger Bilham, Meng Wei, Eric J. Fielding, Janis L. Hernandez, Brian P. E. Olson, Pamela J. Irvine, Nichole Knepprath, Robert R. Sickler, Xiaopeng Tong, and Martin E. Siem

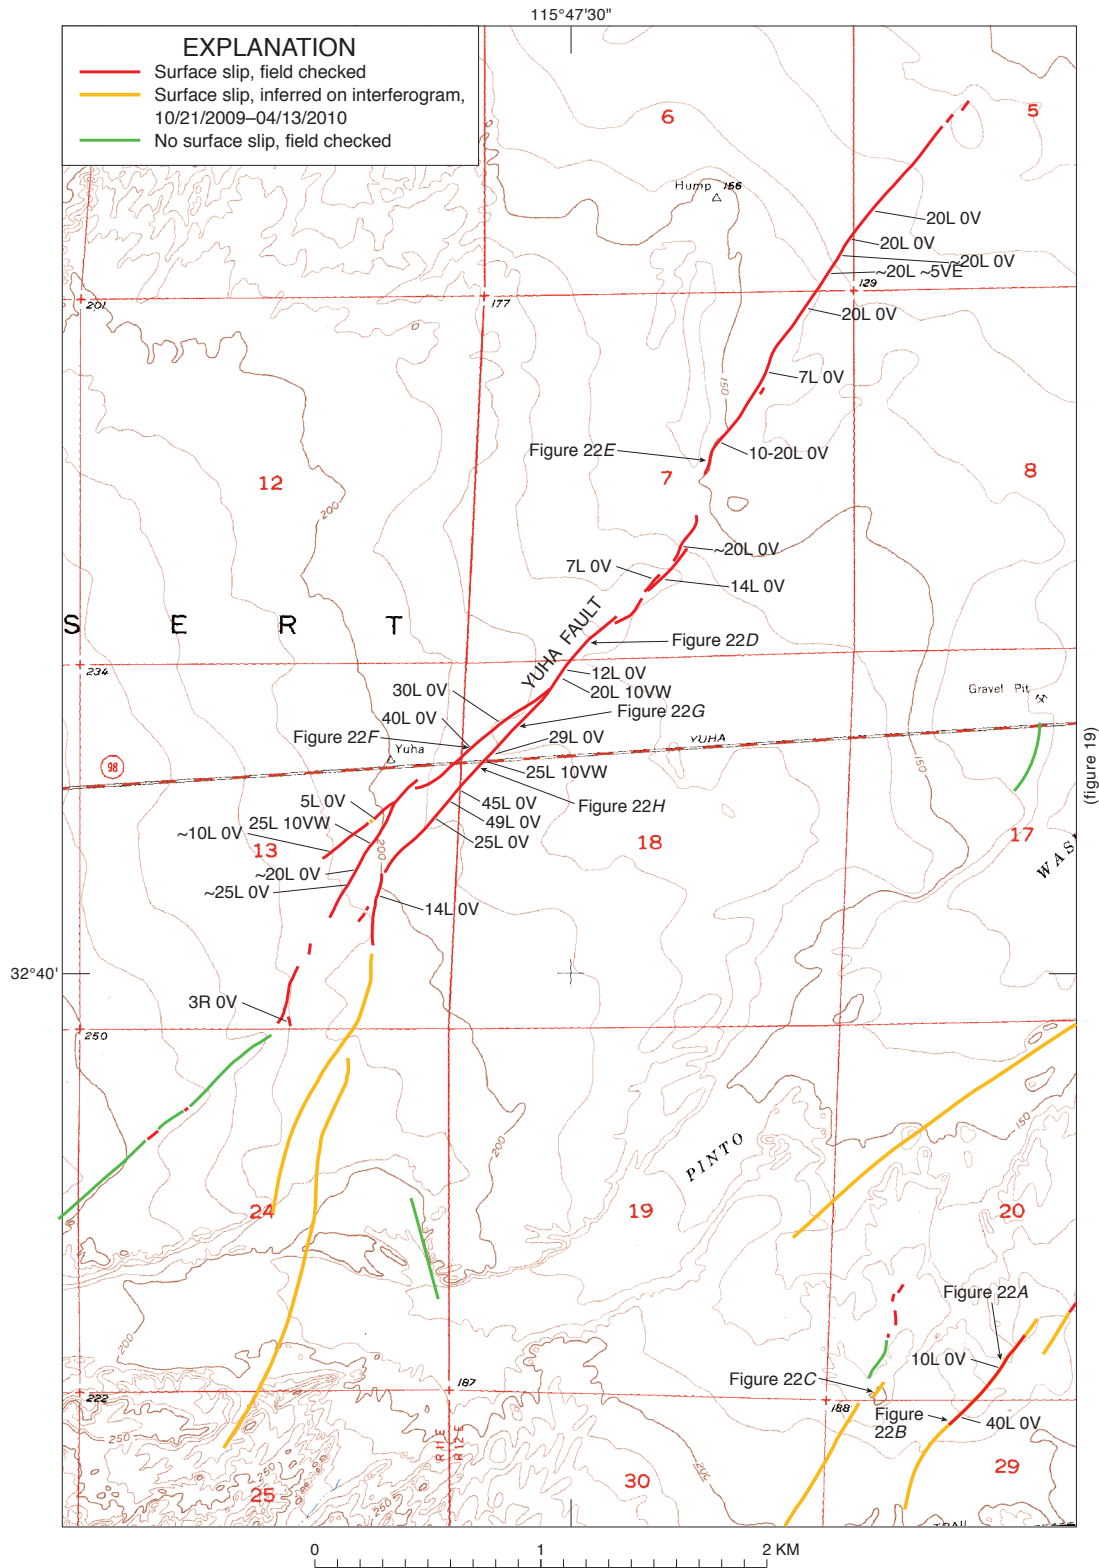
Field checks of surface breakage along a previously unrecognized northeast-trending, left-lateral fault in the Yuha Desert began two days after the El Mayor-Cucapah earthquake. Herein we name this fault the Yuha Fault, for the nearby bench mark “Yuha” (fig. 21). Three of us (M.J.R., J.A.T., and K.J.K.) checked the Yuha Fault in the areas both north and south of State Highway 98 (figs. 17, 21) on April 6 and 7, 2010. Field checks were also made farther south of the initial mapping (by J.A.T., P.J.I., and J.L.H.) on April 9–11, 2010. Further field checks of aerial photographic lineaments northwest of previously mapped fault breakage and north of State Highway 98 were made on May 11 and 12 (J.A.T. and K.J.K.) and again on May 27, 2010 (M.J.R.). The Yuha Fault is about 5–7 km long and, locally, has a subtle to well-expressed fault scarp (figs. 22B, C).

Figure 21. Map of faults and surface fractures in central Yuha Desert. Faults shown are the Yuha Fault and several faults south of Pinto Wash (Sections 20, 29–30). Amount of slip shown in millimeters for both right-lateral (R), or left-lateral (L), and vertical (V) components. Vertical component of slip, where present, is indicated with either west (W) or east (E) side up. Map base from a portion of the Yuha Basin 7 1/2-minute topographic quadrangle. See figure 17 for location of map area.

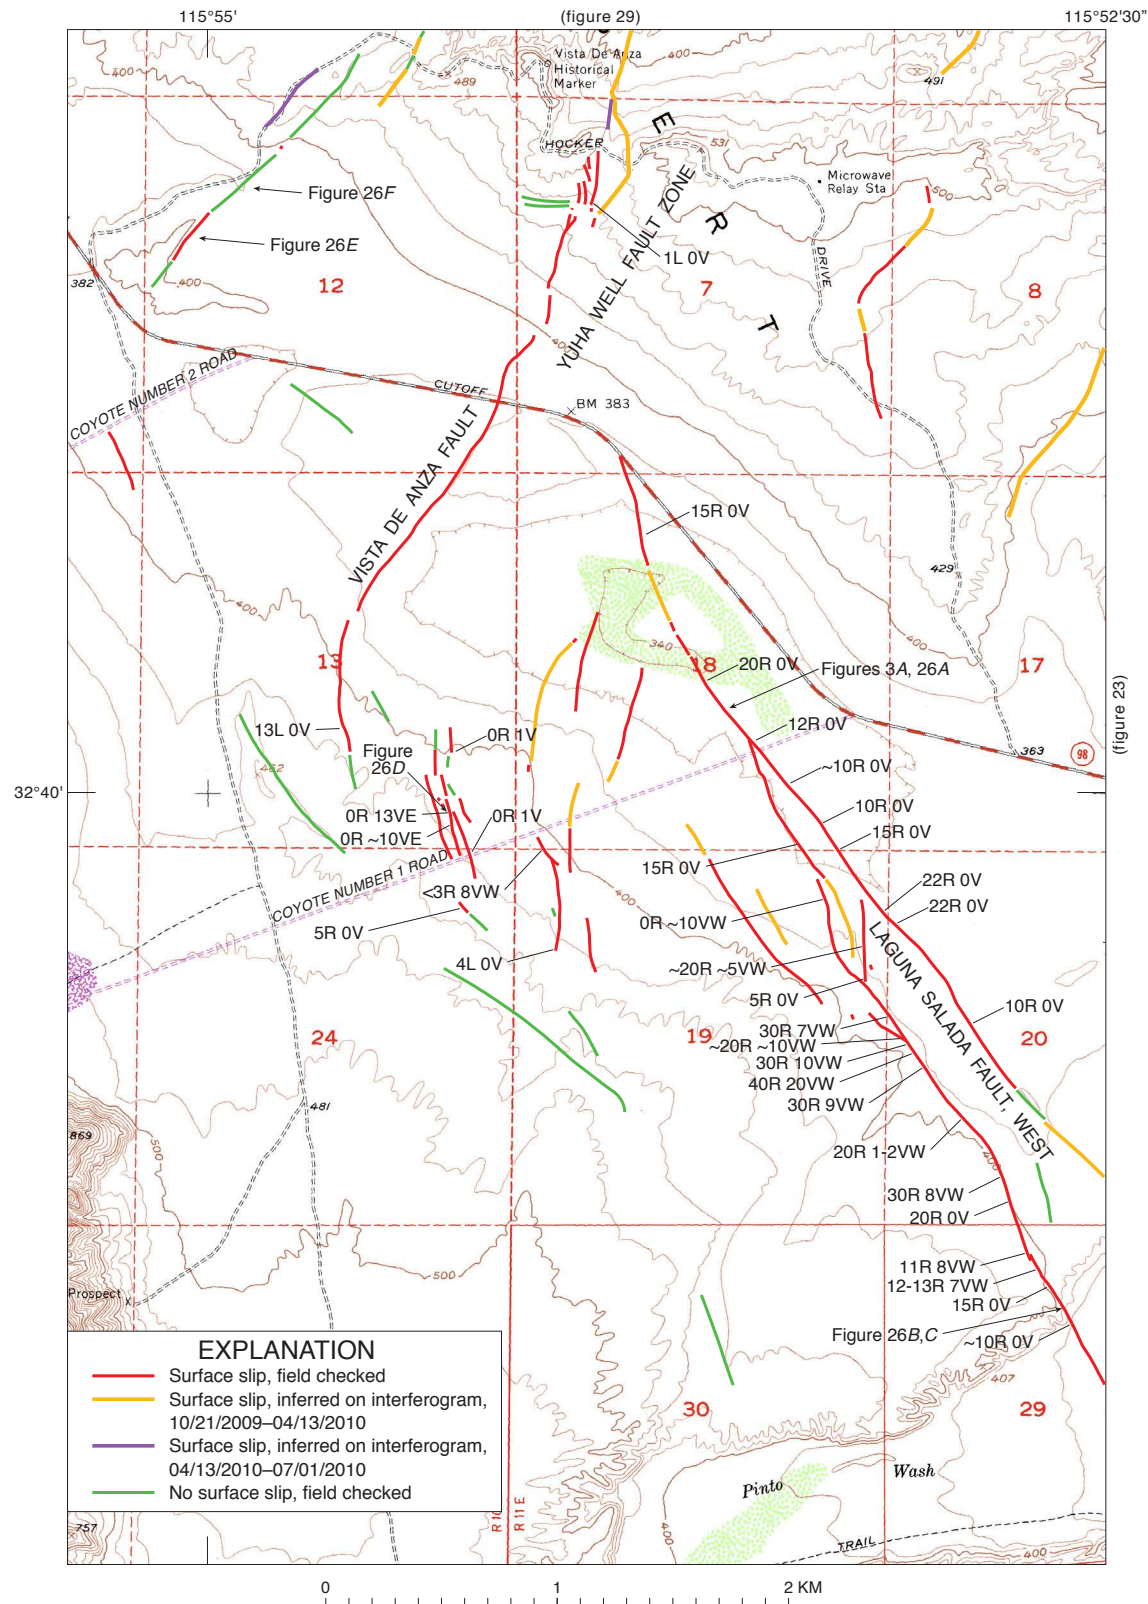
Figure 25. Map of faults and surface fractures in the central Yuha Desert. Faults include the west branch of the Laguna Salada Fault and the southwestern end of the Yuha Well Fault Zone. Amount of slip shown in millimeters for both right-lateral (R), or left-lateral (L), and vertical (V) components. Vertical component of slip, where present, is indicated with either west (W) or east (E) side up. Map base from a portion of the Coyote Wells 7 1/2-minute topographic quadrangle. See figure 17 for location of map area.

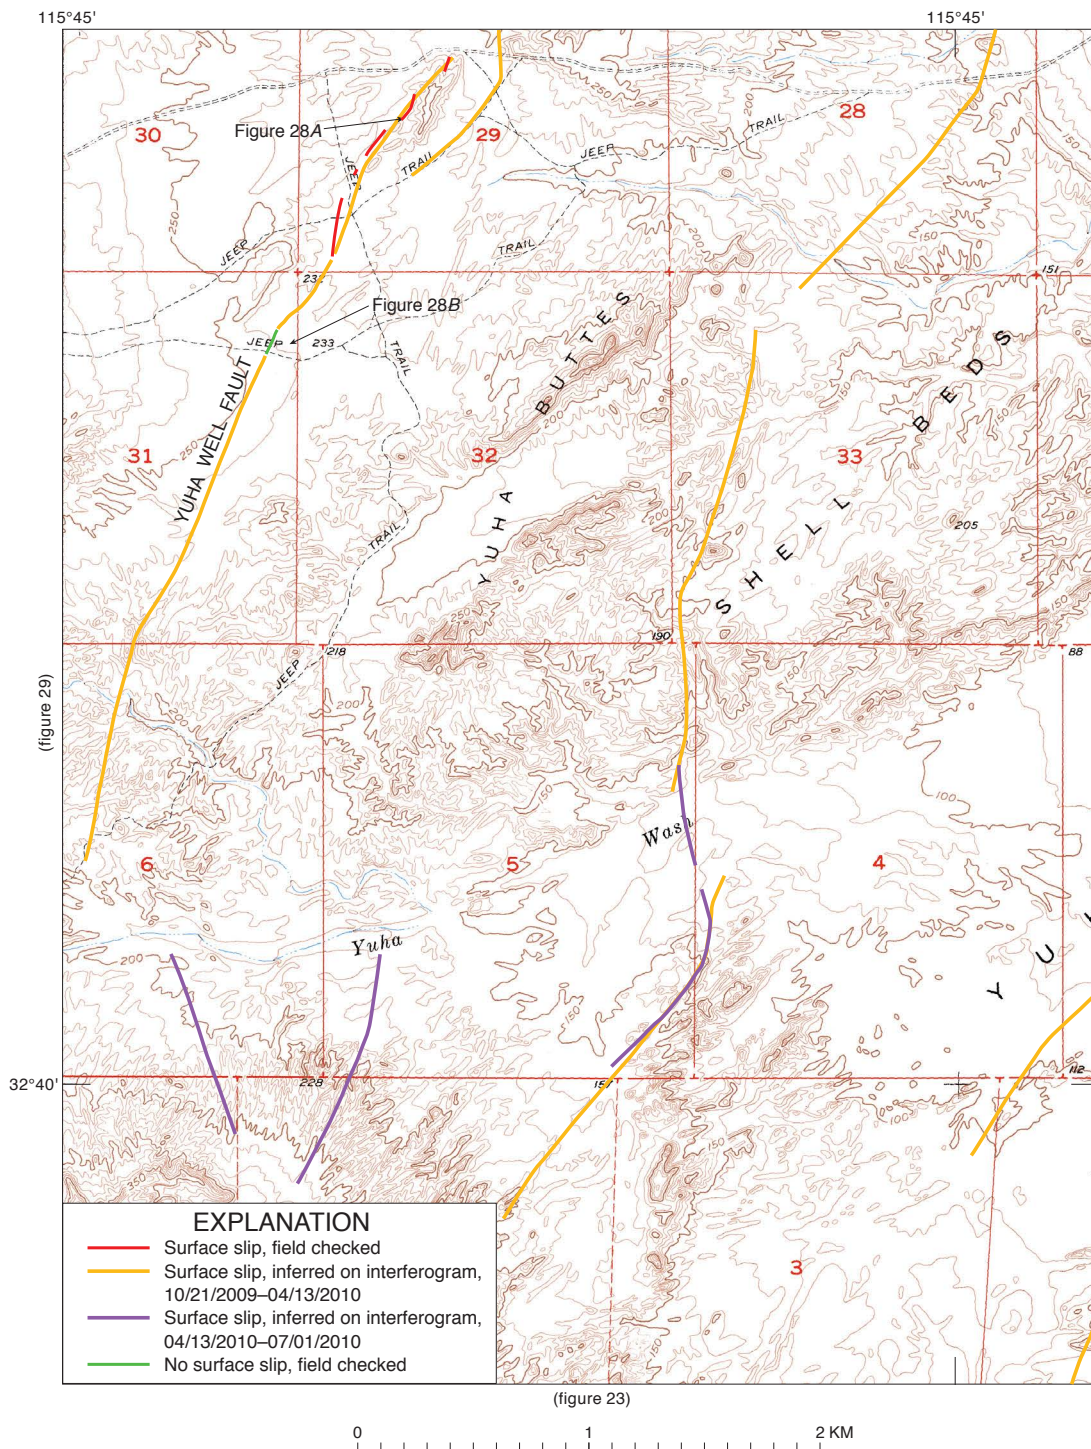
Figure 27. Map of faults and surface fractures in the central Yuha Desert. Faults shown are part of the Yuha Well Fault Zone. Map base from a portion of the Yuha Basin 7 1/2-minute topographic quadrangle. See figure 17 for location of map area.

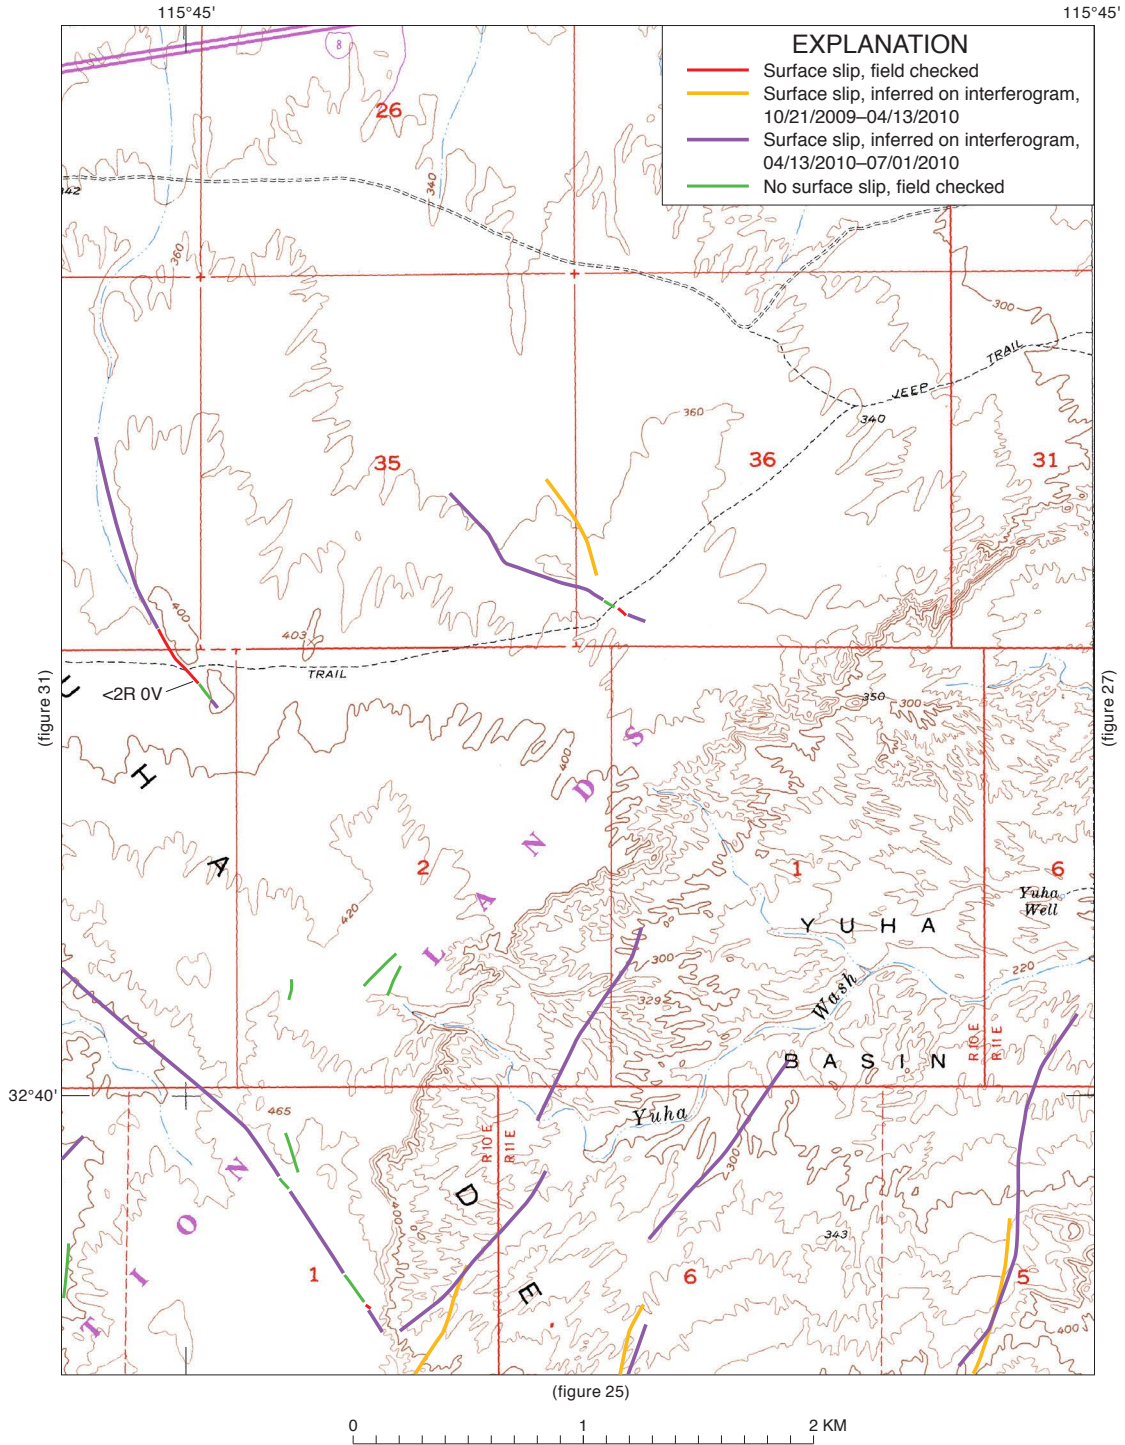
Figure 29. Map of faults and surface fractures in the Yuha Desert. Amount of slip shown in millimeters for both right-lateral (R) and vertical (V) components. Map base from a portion of the Coyote Wells 7 1/2-minute topographic quadrangle. See figure 17 for location of map area.

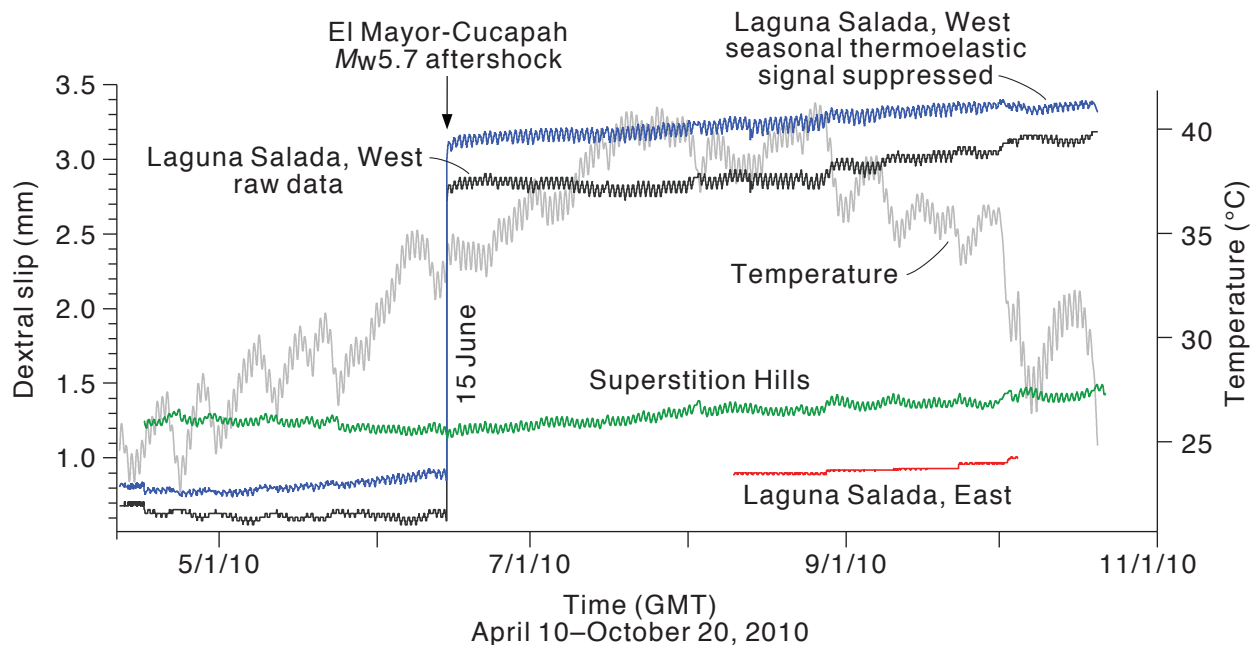
On April 10, 2010, one of us (R.B.) installed creepmeters across both the east and west branches of the Laguna Salada Fault (figs. 17, 30). The creepmeter across the Laguna Salada Fault, west branch, recorded 2.2 mm of dextral slip at the time of the M_w 5.7 aftershock on June 14, 2010 (local time; June 15, GMT). A continuous recorder was not installed on the east branch until August, but a caliper with 10- μ m resolution showed no offset between May and August. Nor was slip observed on any other of the nearby creepmeters at the time of this large aftershock (fig. 30).

Figure 30. Creepmeter data for M_w 5.7 aftershock of June 14, 2010, which was located about 7 km southeast of Ocotillo (fig. 17). Aftershock triggered more than 2 mm of dextral slip on the west branch of the Laguna Salada Fault.

on the Laguna Salada Fault, west branch, as measured by a creepmeter (fig. 30). Of interest, is the possibility of either afterslip or background creep seen in the creepmeter records shown in figure 30. A much longer period of measurement is needed to fully address these possibilities.

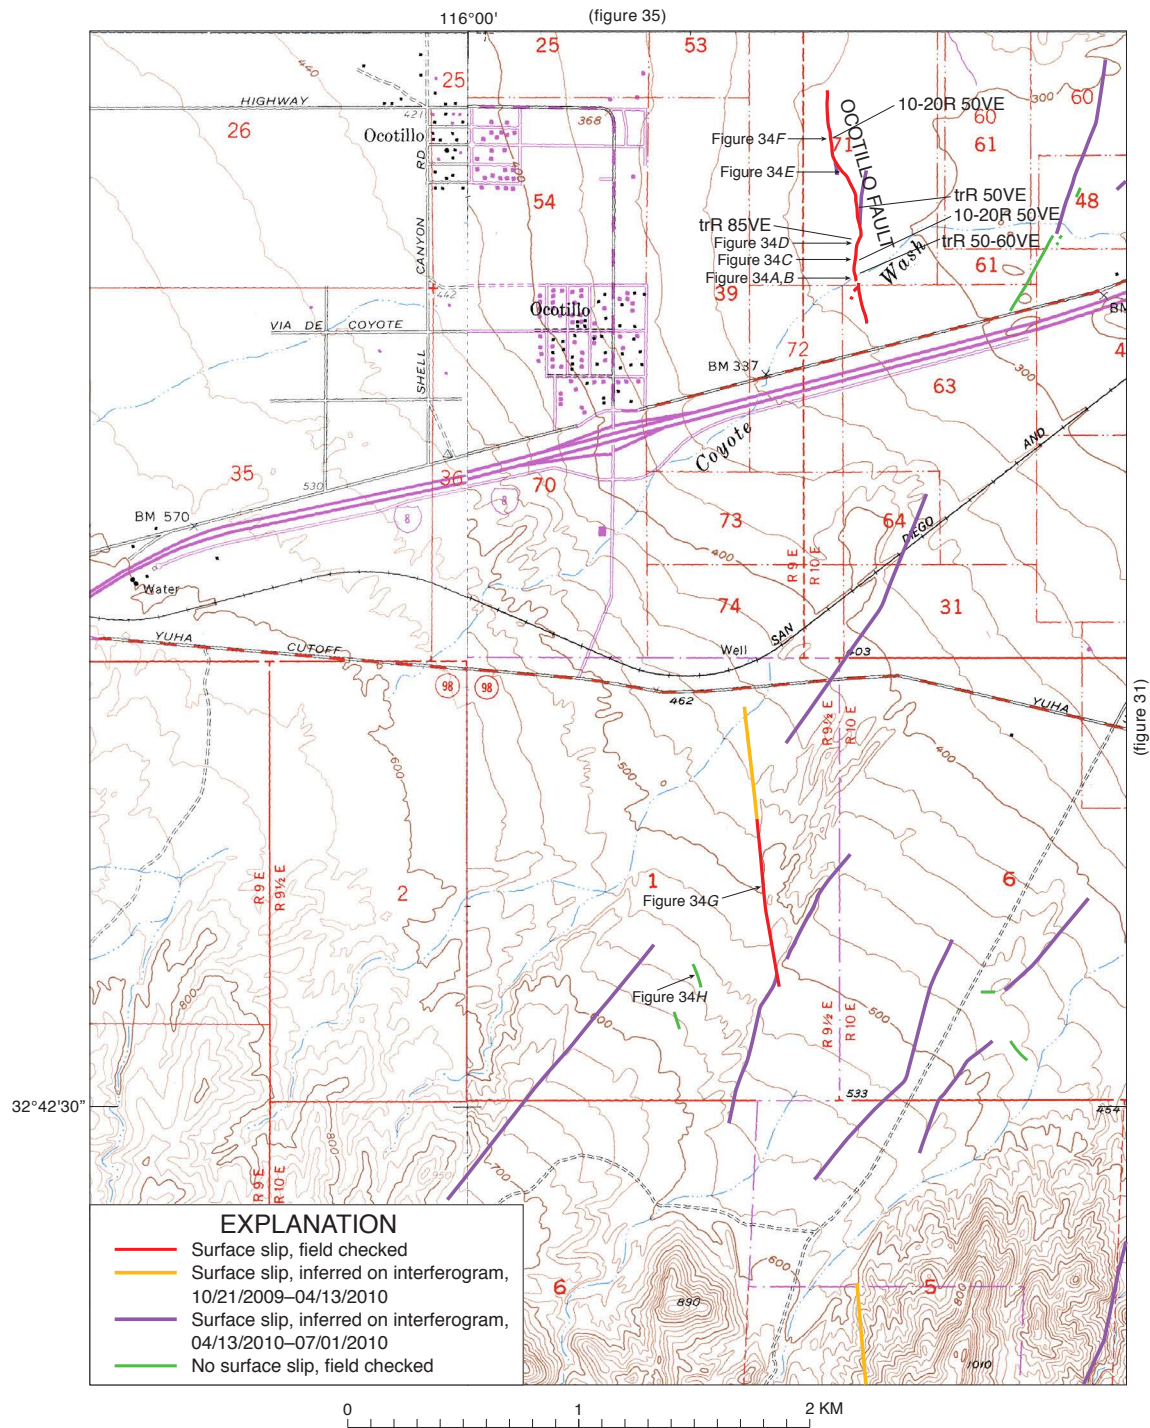
Within the southern Ocotillo Fault Zone, continuous surface slip was mapped along a preexisting scarp (figs. 33, 34G). Relatively continuous surface breakage was also identified to the north (fig. 35) and died out south of a preexisting scarp (fig. 36). Less continuous surface slip was also observed on a similarly oriented fault north of the Elsinore Fault (fig. 35, Section 18).

Figure 33. Map of faults and surface fractures in the Yuha Desert surrounding the community of Ocotillo. Amount of slip shown in millimeters for both right-lateral (R) and vertical (V) components. Vertical component of slip, where present, is indicated with either west (W) or east (E) side up. 'tr' indicates trace amount. Map base from portions of the Coyote Wells and In-Ko-Pa Gorge 7 1/2-minute topographic quadrangles. See figure 17 for location of map area.

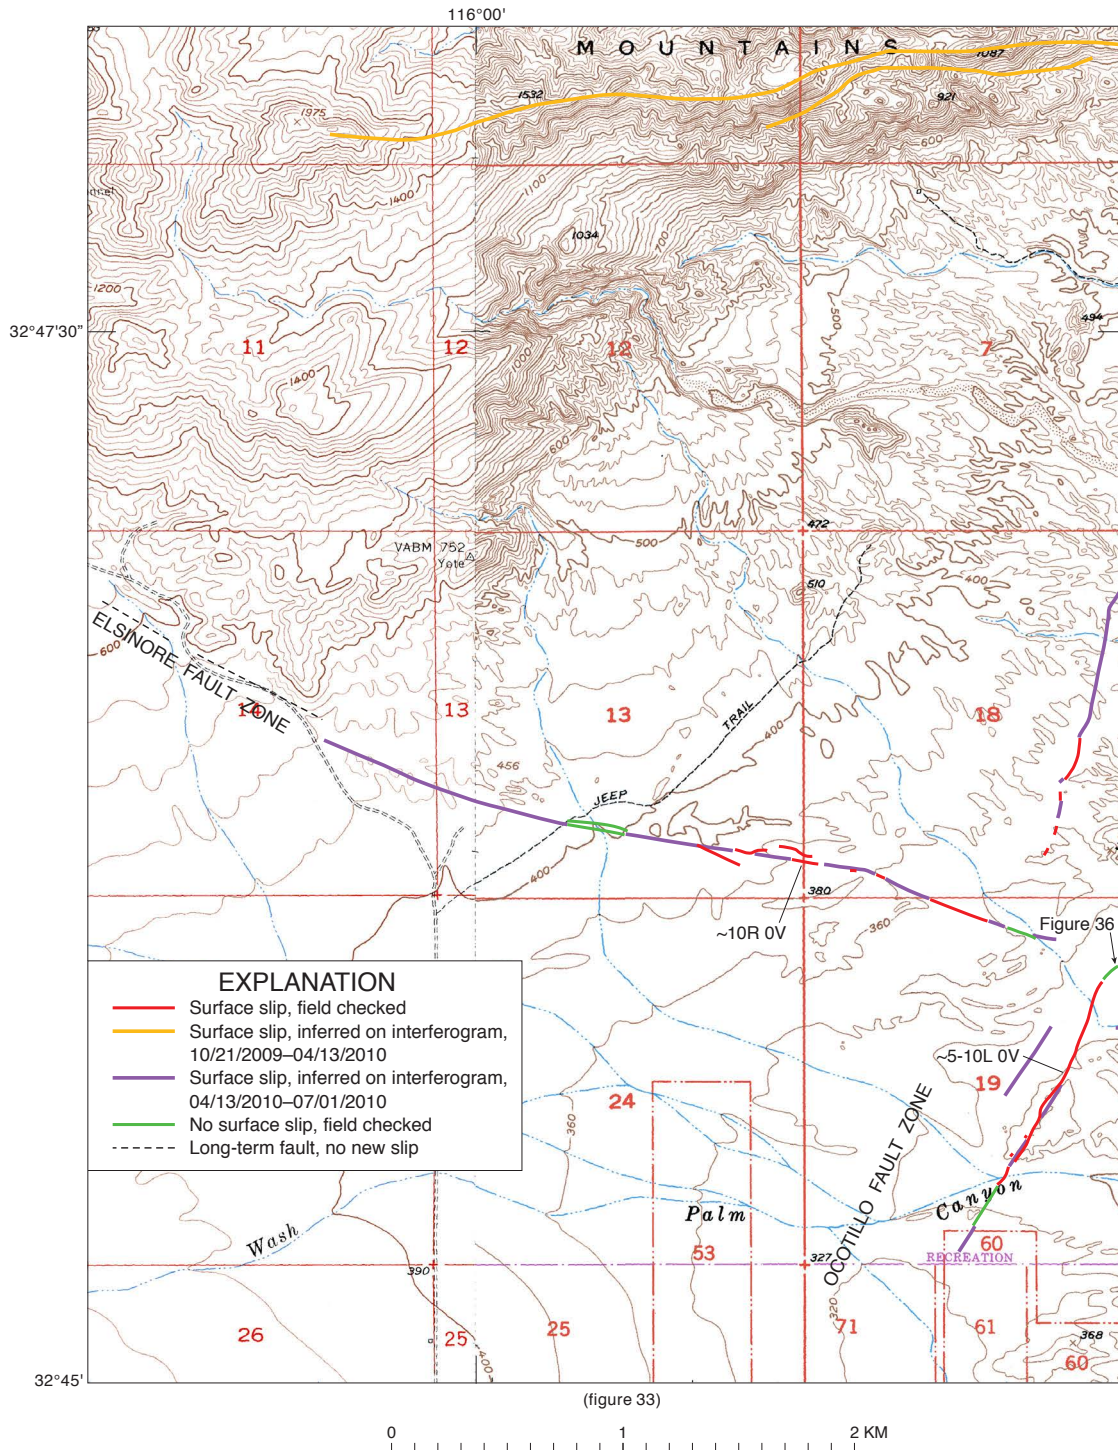
Figure 35. Map of faults and surface fractures in Yuha Desert. Amount of slip shown in millimeters for both right-lateral (R), or left-lateral (L), and vertical (V) components. Map base from portions of the Painted Gorge and Carrizo Mountain 7 1/2-minute topographic quadrangles. See figure 17 for location of map area.
